DUTCH  
SAFETY BOARD

# Loss of control after interrupted winch launch, Gilze-Rijen Air Base

*The Hague, May 2021*

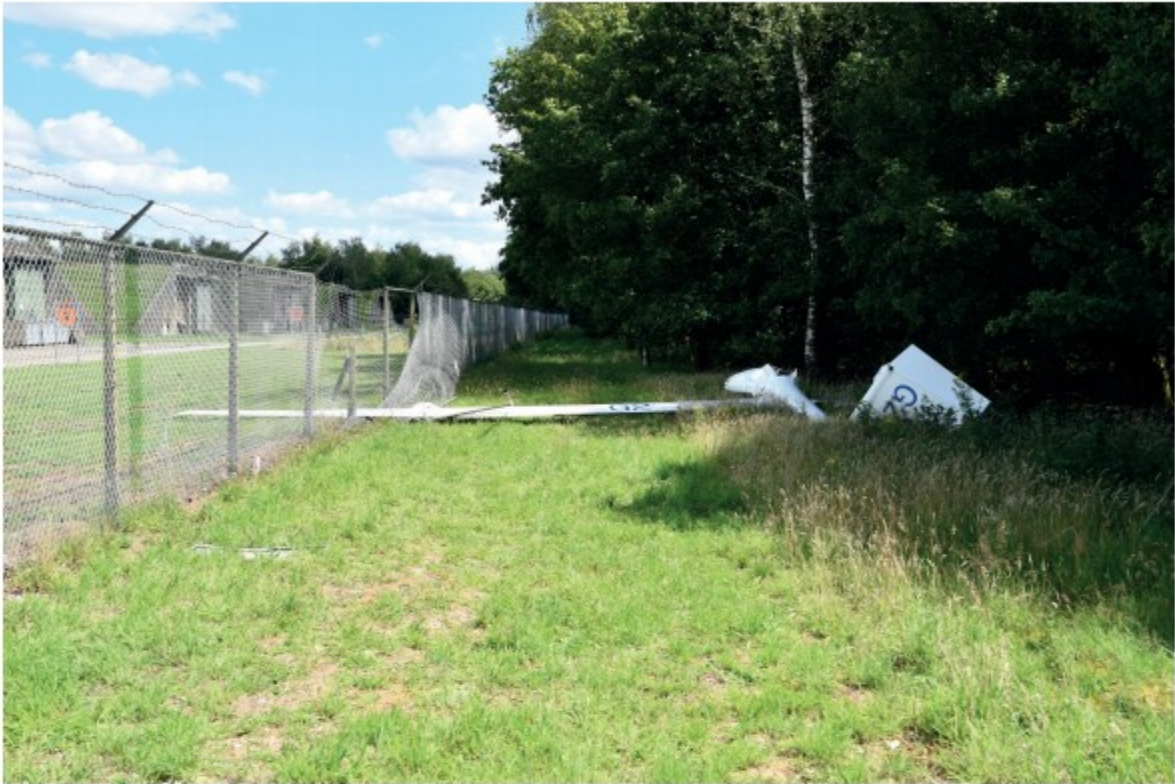
Figure 1: Accident location. (Source: Dutch Aviation Police)

The right wing of the glider ended up on a fence. The fence was damaged as a result (see Figure 1).

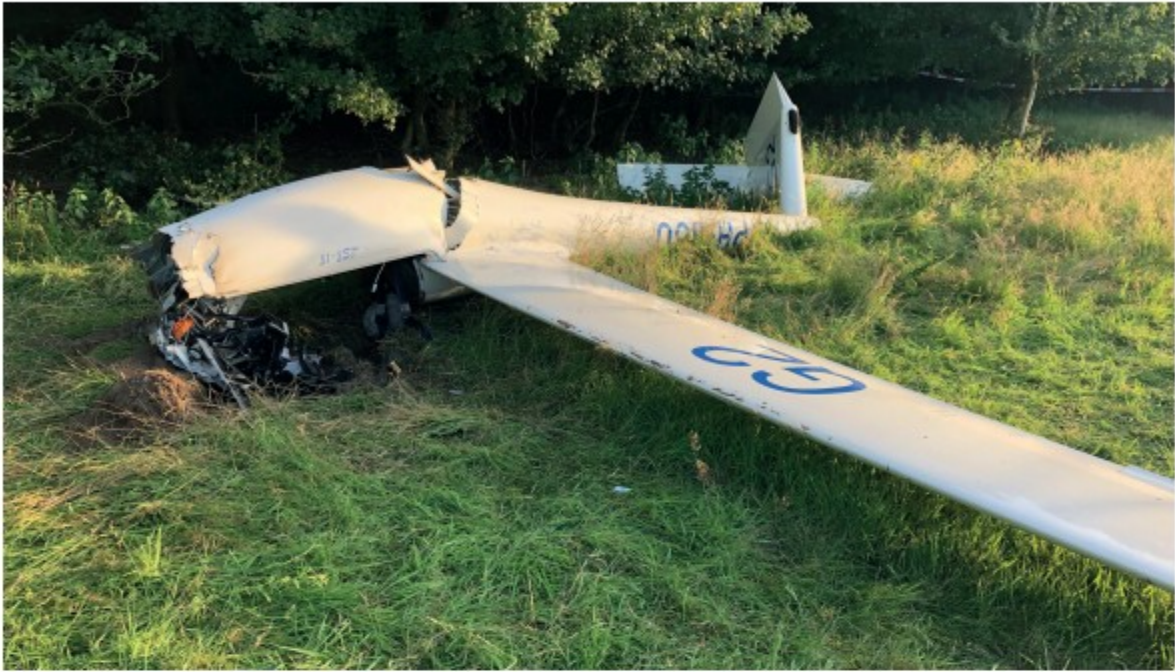
The nose was destroyed and the tail had broken off as a result of the crash. The fuselage was almost broken in half at the level of the wings. The wheel bay and the cockpit were severely damaged (see Figure 2). The right wing was damaged at the point where it hit the fence. The underside of the trailing edge of the left wing was damaged. The glider was beyond repair.

Figure 2: Wreckage of the glider. (Source: Dutch Safety Board)

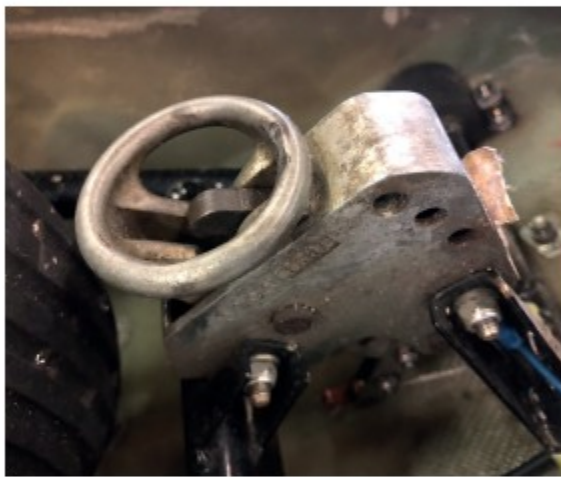
The winch cable is connected to the glider via the centre of gravity release hook (see Figure 3), which is attached to the bottom of the fuselage near the landing gear (see Figure 5). The pilot can release the cable during the winch launch, by pulling the yellow T-shaped handle in the cockpit. The cable release handle in the LS8 is normally guided a little further into the cockpit, via a molded sleeve<sup>17</sup>, to enable the pilot to access it better during flight (see Figure 4).

The hook has automatic safety release features, governed by a special solid-steel ring. It operates on kinematic principles. The solid, high-grade steel ring takes the lateral load of the cable and governs the automatic release. After 2,000 starts, the release hook must be sent to manufacturer for an overhaul. According to the records, PH-1150 had made a total of 1,737 flights with this hook up to and including 11 July 2020.

Figure 3: The centre of gravity release hook of PH-1150. (Source: Dutch Safety Board)

The interruption of the winch launch at approximately 200 metres was caused by a premature winch cable release of the centre of gravity hook.

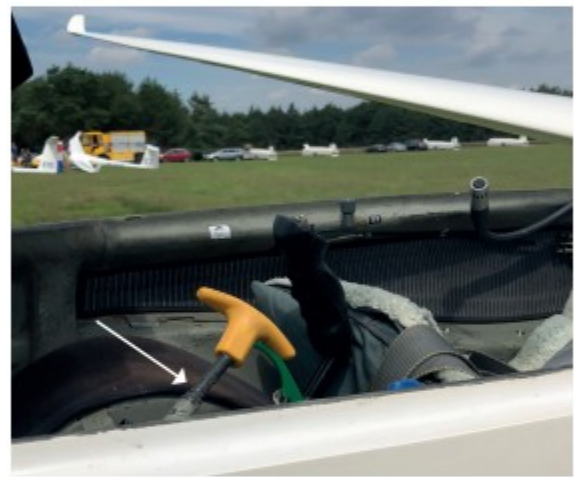
Figure 4: Molded sleeve and yellow release T-shaped handle in another LS8's cockpit. (Source: Dutch Safety Board)

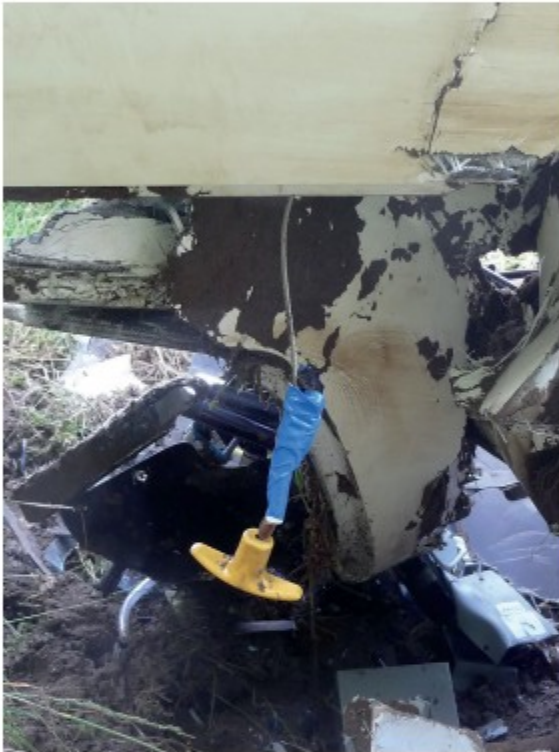
As a result of the broken molded sleeve, the yellow release handle in the cockpit, which is connected to the release cable, hung loosely. Because of this, it was possible that the release handle was hanging outside the cockpit when the canopy was closed. This is undesirable, because then the canopy cannot be closed properly and the handle is also not accessible to the pilot. Hence a repair was carried out. The purpose of the repair was to bring the molded sleeve (and also the yellow handle) more in the pulling direction towards the pilot. In the workshop it was found that the repair of the broken molded

sleeve would take longer than hoped for and it was therefore decided to make a temporary repair.<sup>31,32</sup> See Figure 6.

Figure 6: The temporary repair of the molded sleeve, as found at the accident site.  
(Source: Dutch Safety Board)

The pilot, who experienced the third premature cable release, observed after the next (and last) flight of PH-1150 that day, that the repair to the molded sleeve had broken and detached.

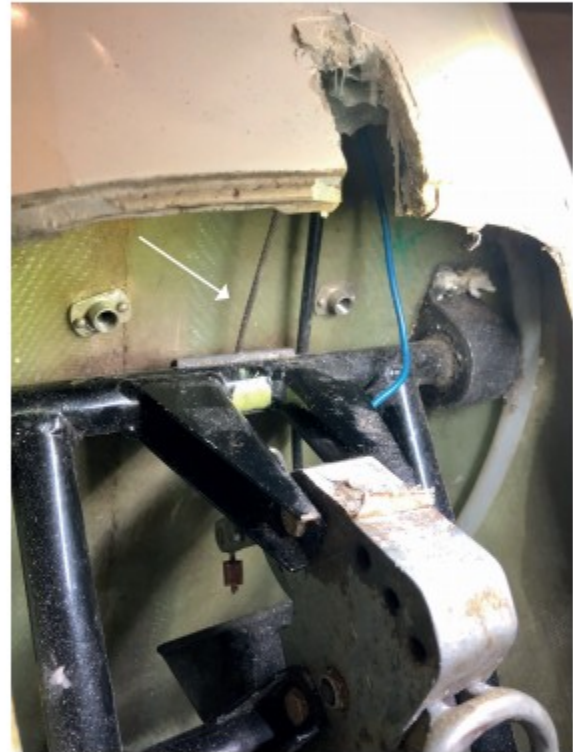
Figure 7 shows the routing of the metal release cable after it had been adjusted on 8 July 2020. As visual, the metal cable runs behind a crossbar of the landing gear. It was found, when the glider was in the workshop, that this routing ran incorrectly along the landing gear on this side of the crossbar, as shown in Figure 7. There was a visible wear spot on the crossbar of the landing gear along which the cable had run.

Figure 7: The metal cable of the release mechanism after the routing adjustment.  
(Source: Dutch Safety Board)

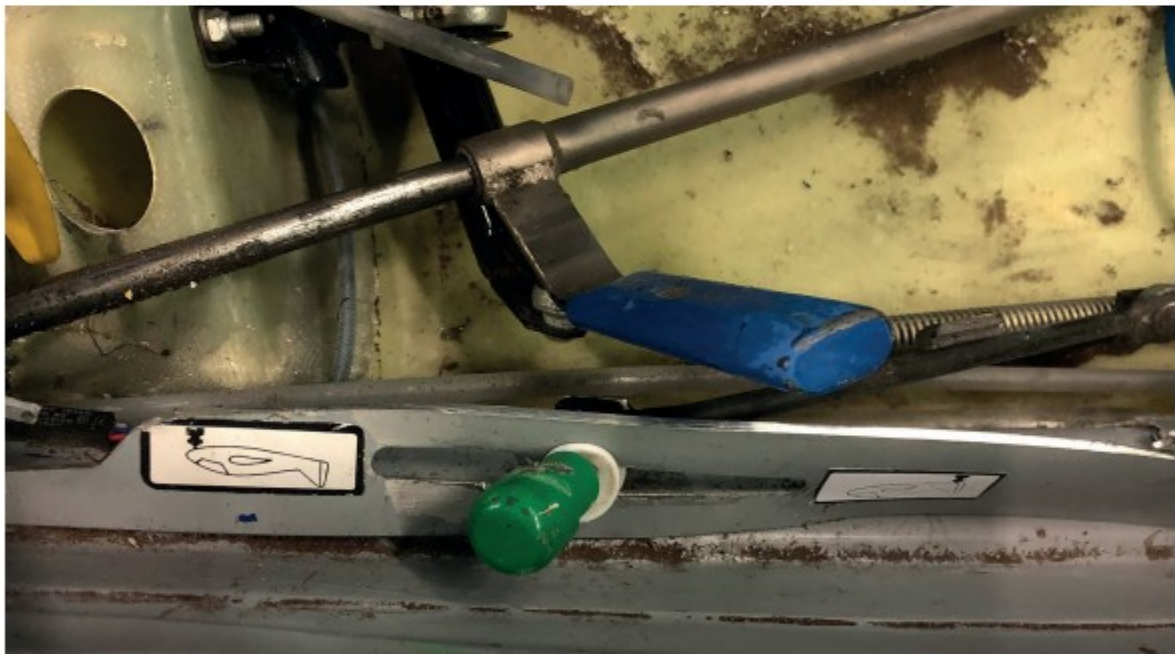
The nose section of the glider was destroyed and the cockpit was severely damaged. The green trim position indicator was found near the neutral position, just a bit forward of it: see Figure 8. The slot in which the indicator moves, was bent. No marking to indicate the neutral position of the indicator was visible along the slot. The lever to operate the retractable landing gear was found in the 'extended' position. Two orange coloured pieces of lead, of which the text 'LS8' was visible on one, were found in the nose of the cockpit.

*Figure 8: Green trim position indicator and the blue air brake handle. (Source: Dutch Safety Board)*

The green trim position indicator was found near the neutral position, just a bit forward of it. As the slot, in which the indicator moves, was bent, it is possible the indicator had moved as a result of the impact forces. This could not be determined. According to the Flight Manual, the trim should have been set to slightly nose heavy. As the manual is not clear about the exact position the trim should be set to during takeoff, it could not be established if the trim position may have contributed to inadequately lowering of the nose, after the cable disconnected. However, it is unlikely that the trim position had a significant influence on this.

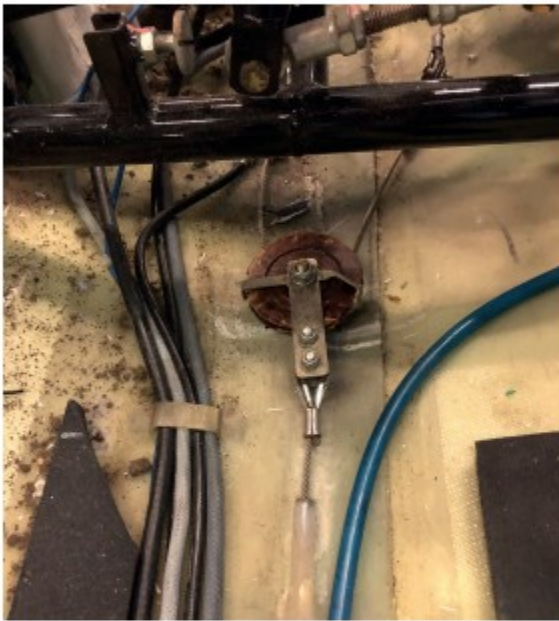
On the inside of the cockpit, under the seat, there is a pulley, made of a synthetic resin<sup>38</sup>, around which a cable runs towards the nose hook.<sup>39</sup> This cable and the pulley are part of the cable release mechanism. The pulley is also connected to a cable that runs backwards and is connected to the centre of gravity hook.<sup>40</sup> See Figure 9. The cable that runs through the pulley to the nose appeared to have come loose from the pulley. See Figure 10. The edge of the pulley was found damaged in some places. A technician stated that no peculiarities of the pulley and cable were found during the last maintenance in the winter.

Figure 9: Pulley and release cable at the bottom of the cockpit. (Source: Dutch Safety Board)

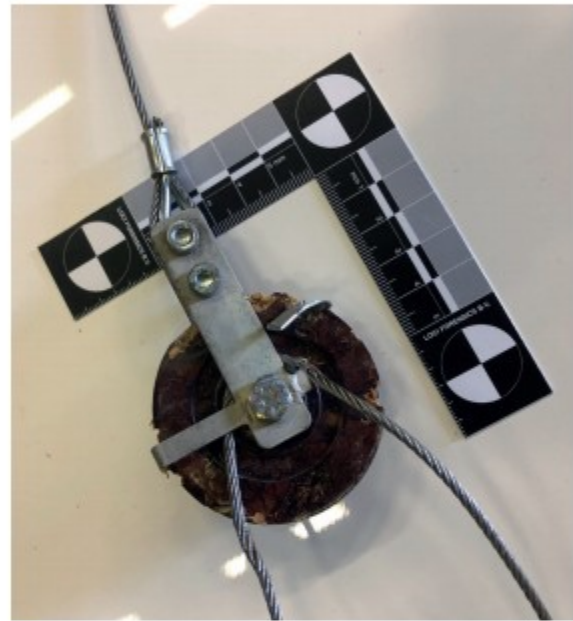
Figure 10: Loose cable around pulley. (Source: Dutch Safety Board)

The cable, which is part of the release mechanism and runs through a pulley to the nose of the glider, appeared to have come loose from the pulley. The edge of the pulley was found damaged in some places. The synthetic resin, from which the pulley is made, becomes brittle over time. This may cause the edges to break. The cause of the damage to the pulley has not been investigated. No peculiarities of the pulley and cable were found during the last maintenance. It is unlikely that the cable came loose while making the repair to the molded sleeve or the adjustment of the routing of the release cable. It is therefore likely that the cable came loose as a result of impact forces during the crash.
