DUTCH  
SAFETY BOARD

# Loss of control after interrupted winch launch, Gilze-Rijen Air Base

*The Hague, May 2021*

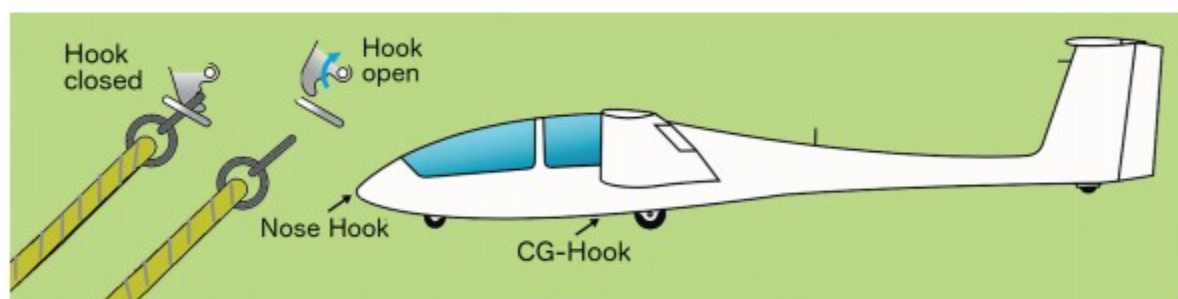
The winch cable is connected to the glider via the centre of gravity release hook (see Figure 3), which is attached to the bottom of the fuselage near the landing gear (see Figure 5). The pilot can release the cable during the winch launch, by pulling the yellow T-shaped handle in the cockpit. The cable release handle in the LS8 is normally guided a little further into the cockpit, via a molded sleeve<sup>17</sup>, to enable the pilot to access it better during flight (see Figure 4).

Figure 5: The location of the centre of gravity (CG) release hook. (Source: *Gliding, The basics in 35 lessons*, D. and R. Corporaal)

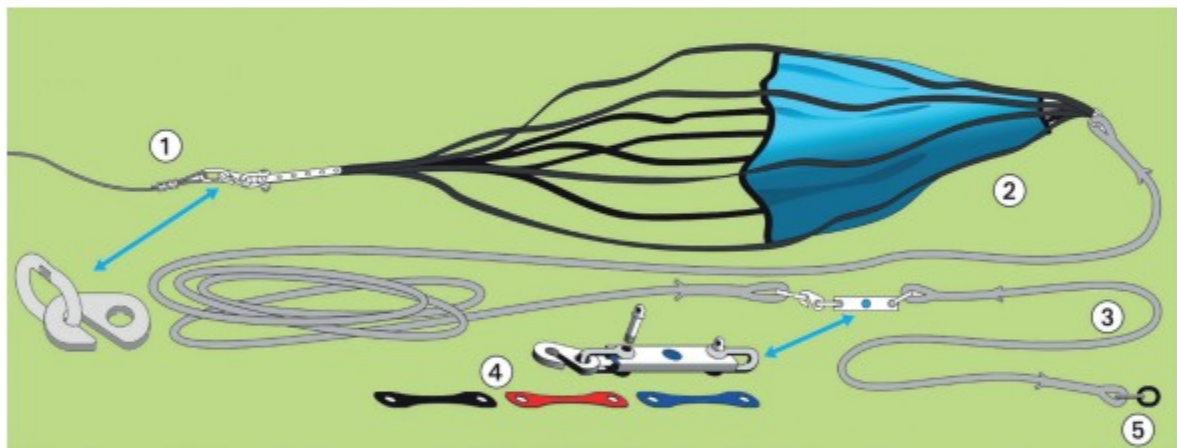
The pilot who experienced the second case (during the third flight of PH-1150 that day), at a height of approximately 200 metres, assumed that the weak link (see Figure 11) had broken and did not report it. He made a flight of 37 minutes. In the evening, when he heard from his wife that the weak link had not broken, he could hardly believe it. His wife, who is also a glider pilot, had contacted the winch operator after the second premature cable release, who told her the weak link was still intact.

Figure 11: Winch cable (1), the cable parachute (2), the shock absorber rope (3), the weak link (4) and the release rings (5). (Source: *Gliding, The basics in 35 lessons*, D. and R. Corporaal)

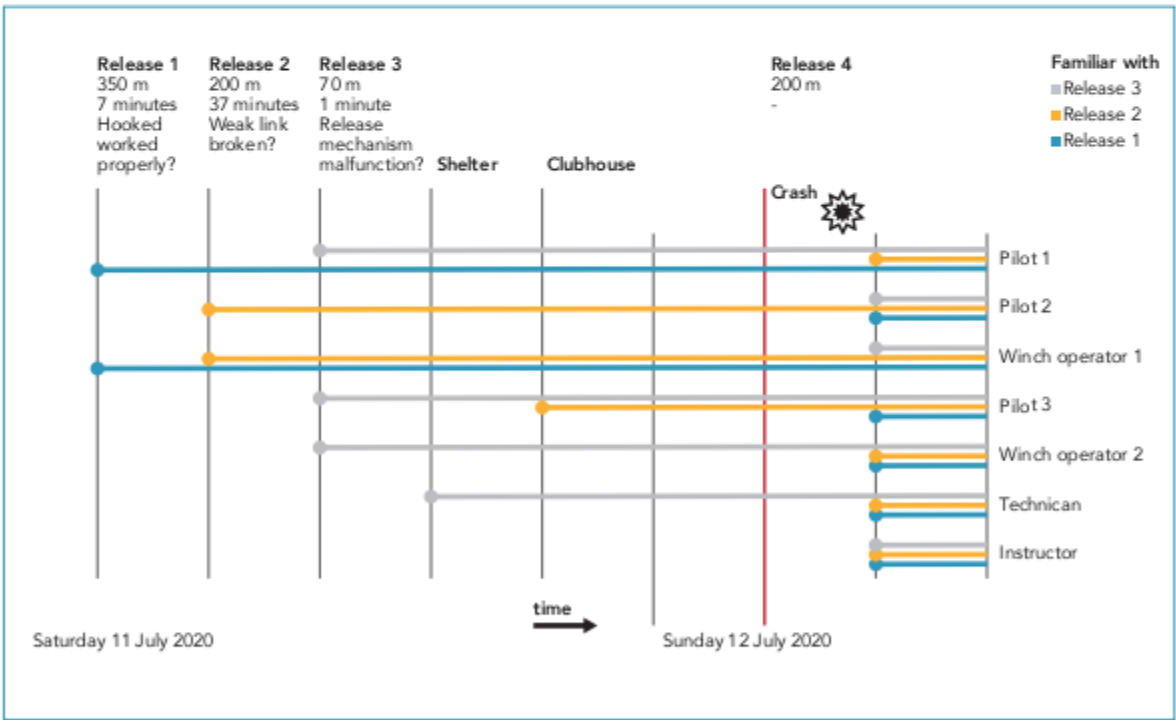
The instructor in charge on 12 July 2020 was not informed about the premature cable release issue of PH-1150 that had occurred three times the day before his shift, nor about concerns about a possible malfunction of the cable release mechanism that needed to be investigated later.

Figure 12: Schematic representation of the times when the main persons involved became aware of the three separate premature cable releases. Pilot 1, 2 and 3 are the pilots involved in respectively the first, second and third premature cable release. Technician is the technician who received the verbal report about one premature cable release. Instructor is the instructor in charge during the accident flight.

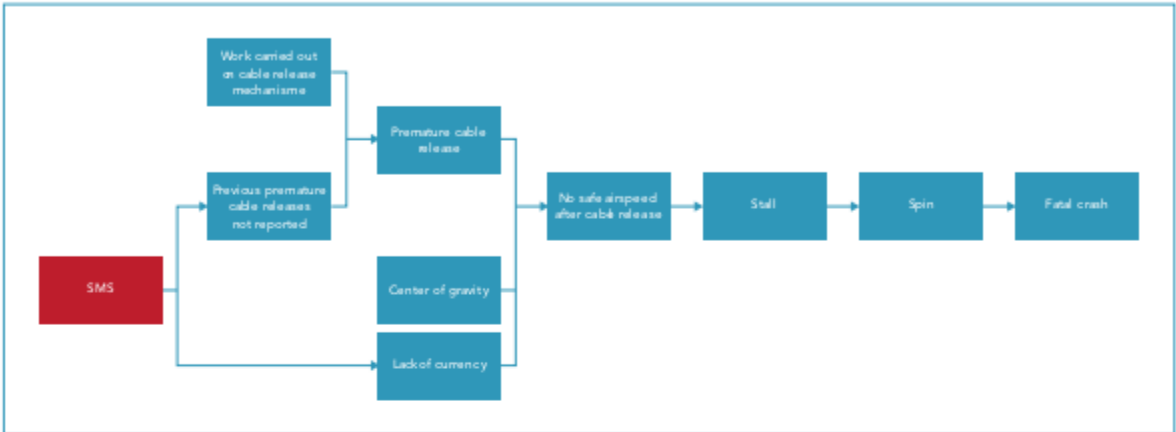
Concluding, a temporary repair had been carried out on PH-1150 and then three times a premature cable release took place. PH-1150 was subsequently not grounded, but made available for flight operations with a malfunction of the cable release mechanism, without

the cause of the cable releases being thoroughly analysed. This in combination with the allocating of PH-1150 to a pilot, with a lack of recent experience on single seater gliders, created a situation in which the accident could occur. The club's safety management system did not ensure that such a situation was prevented from happening.

Figure 14: Schematic representation of the findings. SMS stands for the club's safety management system.
